5 October 2006
Project Number 2645SC01-G
Via US Mail and FAX

Subject: Leavesley Road Four-Parcel Subdivision
Supplement to Fault Investigation Report
Leavesley Road [APN 898-34-002]
Gilroy, Santa Clara County, California

PLATE 1
Fault Set-Back Map

FAULT LOCATION INVESTIGATION
FOR
JAPANESE CULTURAL CENTER
GILROY, CALIFORNIA

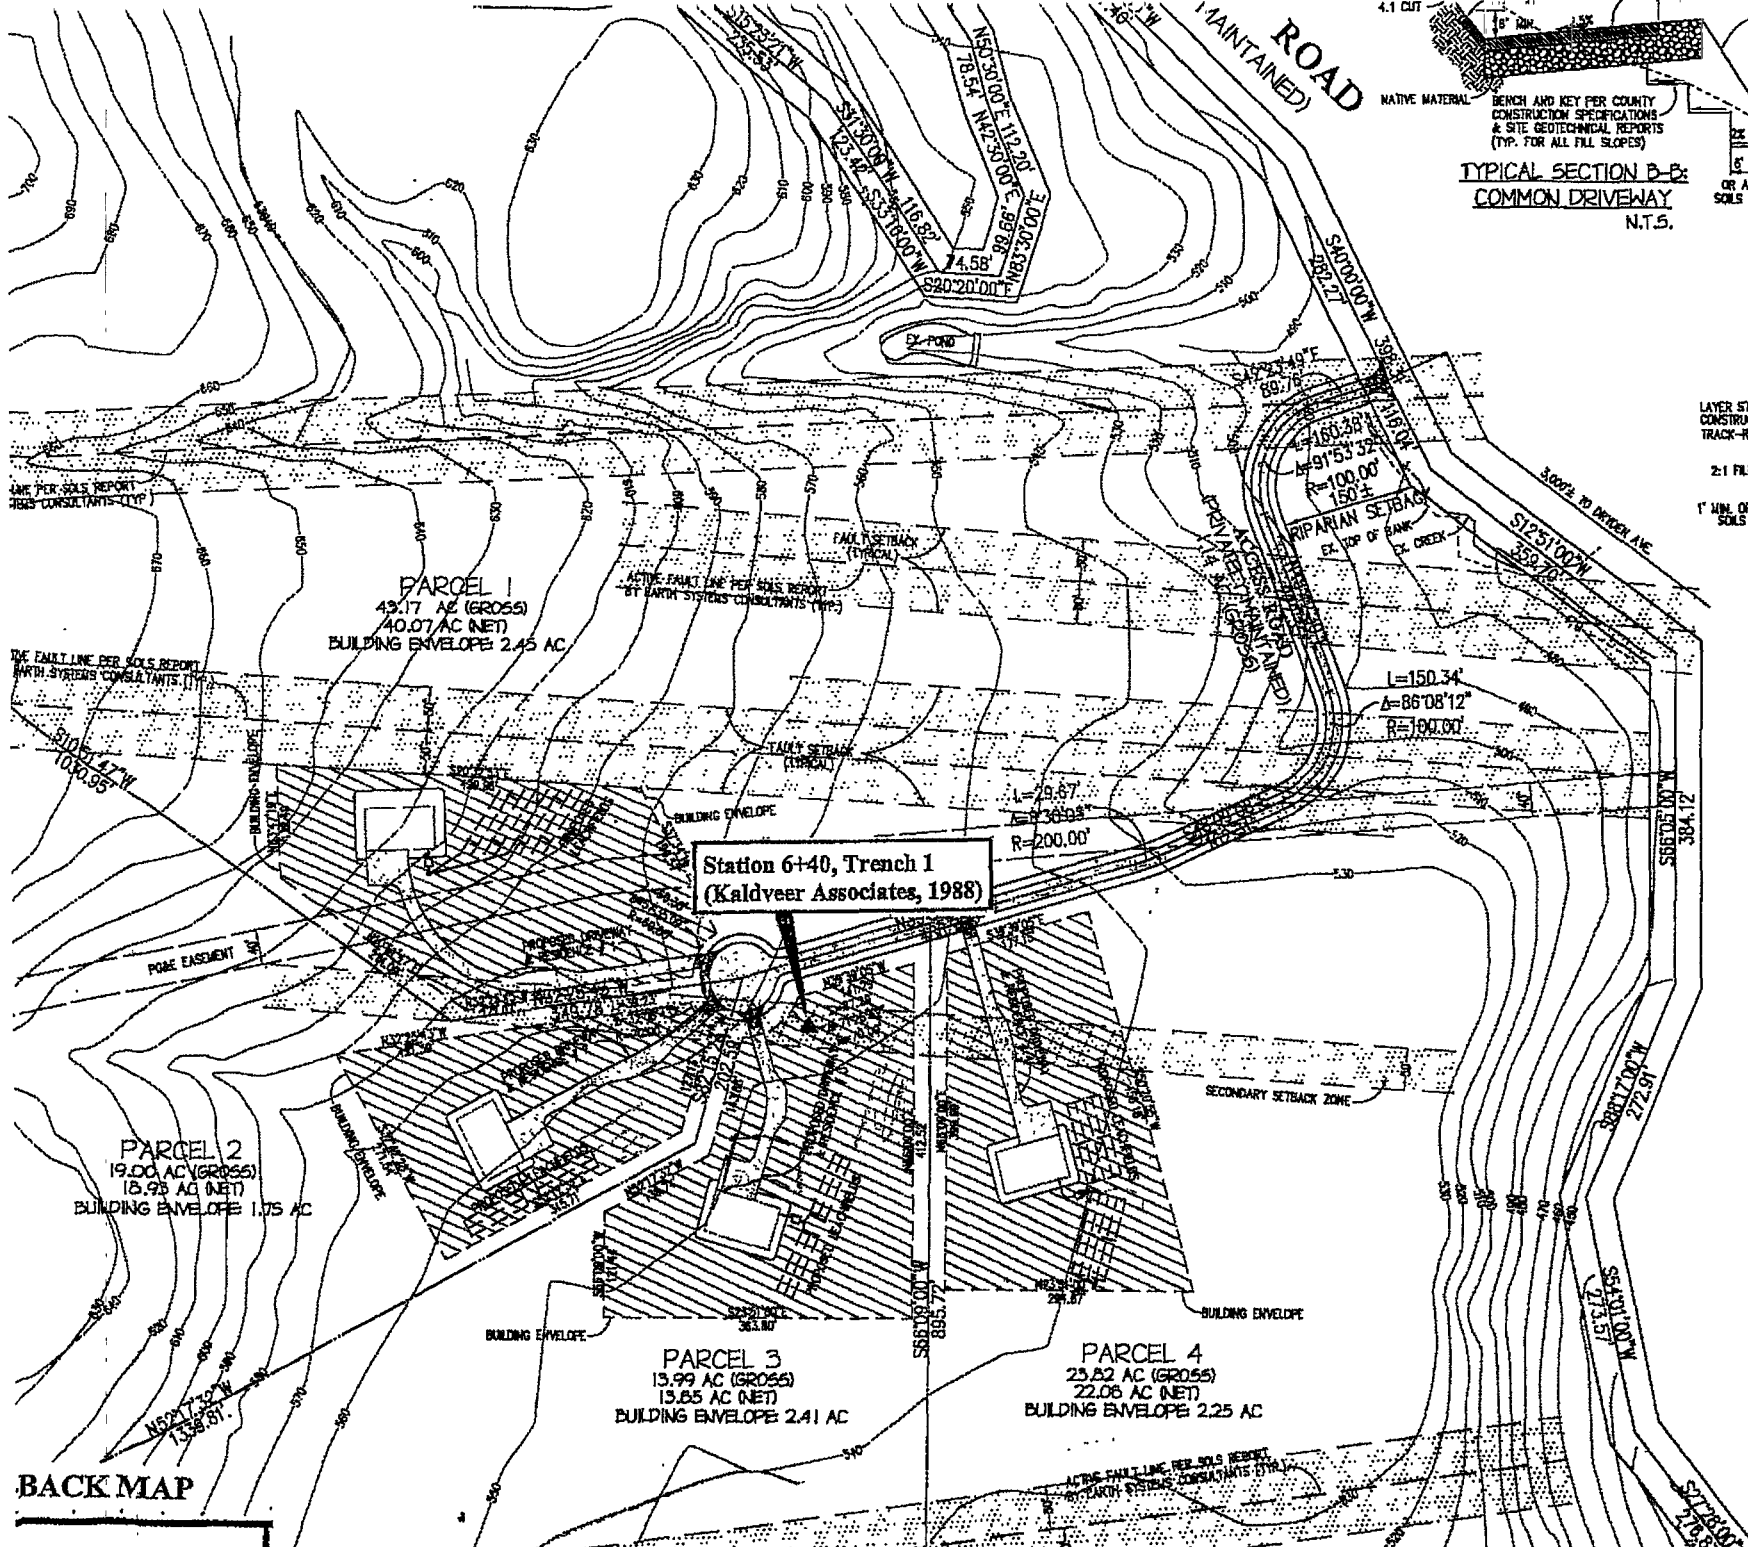
The Santa Clara County Planning Department later required MH Engineering Co. to relocate the previously selected building sites to locations that were not "shadowed" by ESCNC's (2006) exploratory trenches, but were shadowed by an exploratory trench excavated and logged by Kaldveer Associates (1988). Mr. Jim Baker, the County Geologist, subsequently reviewed the trench logs by Kaldveer Associates (1988) and interpreted several features as fault-related. E₂C's discussion with Mr. Baker on 4 October 2006 eliminated two of the suspect subsurface features, resulting in a potentially viable building zone south of the PG&E easement that ranges from approximately 300 to 350 feet wide. However, one of the fault features noted by Mr. Baker is located at station 6+40 in Kaldveer trench T-1 (i.e., 640 feet from the beginning of the trench at sta. 0+0) which is within the potential building zone and is critical to the current layout of the proposed buildings. The feature is a contact between moderately weathered agglomerate to the southwest and deeply weathered, crushed, and intensely fractured tuff to the northeast. The contact is shown as a curved dashed line, which usually indicates a gradational or vague contact. This particular feature does not appear to disrupt the younger surficial soil. However, the trench log by Kaldveer Associates (1988) does not describe or illustrate the contact in sufficient detail to fully demonstrate the nature of the contact (i.e., depositional or tectonic). Additional exploratory trenching would be required at that location in order to further evaluate the contact. However, time constraints make additional trenching impracticable for this project.

As an alternative to further exploratory trenching, we have taken a conservative interpretation of the feature at station 6+40 and recommend a 25-foot building set-back from the feature which will extend subparallel to the general northwest structural trend as shown on the published geologic maps (Plate 1). Since the agglomerate/tuff contact may be depositional rather than fault-related, it is E₂C's recommendation that the typical 50-foot setback be reduced, and a 25-foot set-back be established as shown on Plate 1. The viable building zone for proposed building areas no. 2,3,and 4 now is roughly 275 to 325 feet wide and located south of the PG&E easement (Plate 1). Proposed building area no. 1 has been relocated to the originally proposed area north of the PG&E easement. No structures intended for human habitation should be built wholly or partly within a fault set-back. Proposed leachfields may be located within a set-back zone, but should not be placed directly over a mapped fault trace. The proposed building sites and leachfield locations shown on Plate 1 conform to our recommended building setbacks.

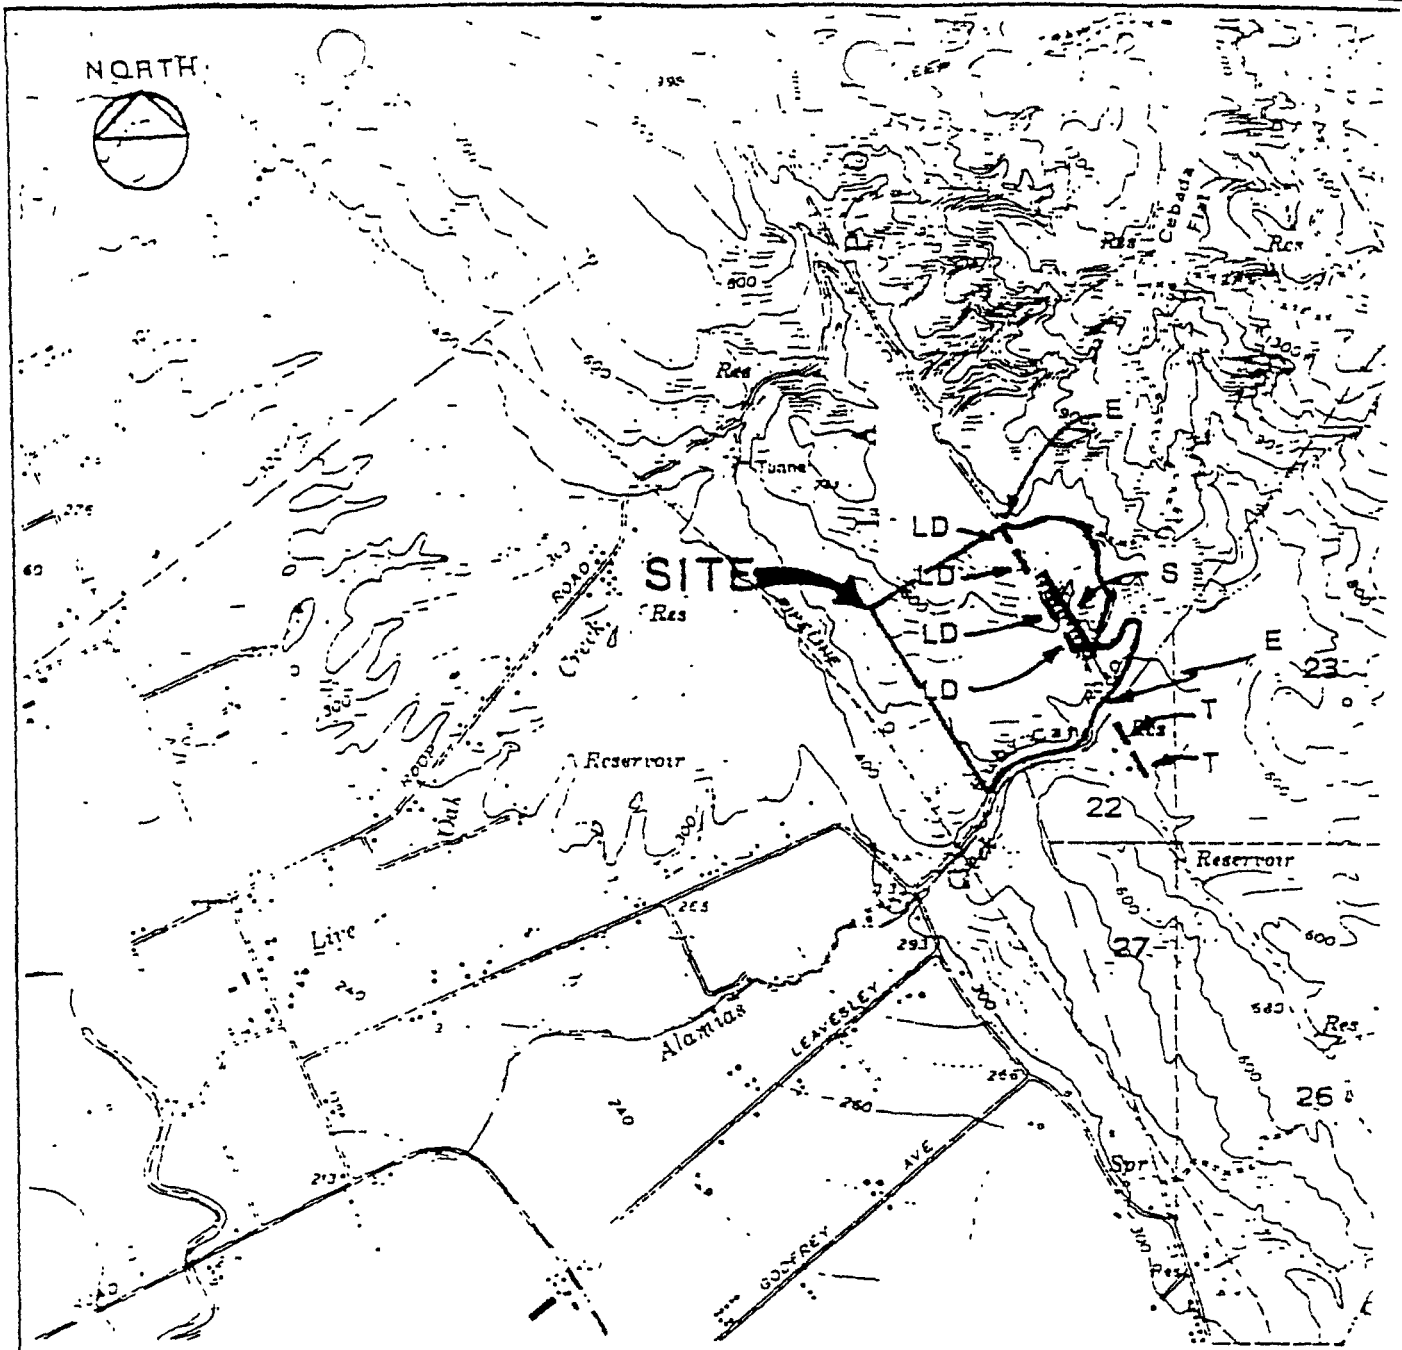
Our examination of these photos along the trace of the Calaveras Fault (through the subject site) indicates recent faulting. Tonal color contrasts trending northwest are present just south of the site. Through the site following the same trace, there are several well defined shallow linear depressions and a steep scarp. No other specifically fault-related features are noted crossing the site. Our observations of geomorphic features at the site are presented in the Photolinement Interpretation Map, Figure 6.
