5 October 2006
Project Number 2645SC01-G
Via US Mail and FAX

Subject: Leavesley Road Four-Parcel Subdivision
Supplement to Fault Investigation Report
Leavesley Road [APN 898-34-002]
Gilroy, Santa Clara County, California

PLATE 1
Fault Set-Back Map

FAULT LOCATION INVESTIGATION
FOR
JAPANESE CULTURAL CENTER
GILROY, CALIFORNIA

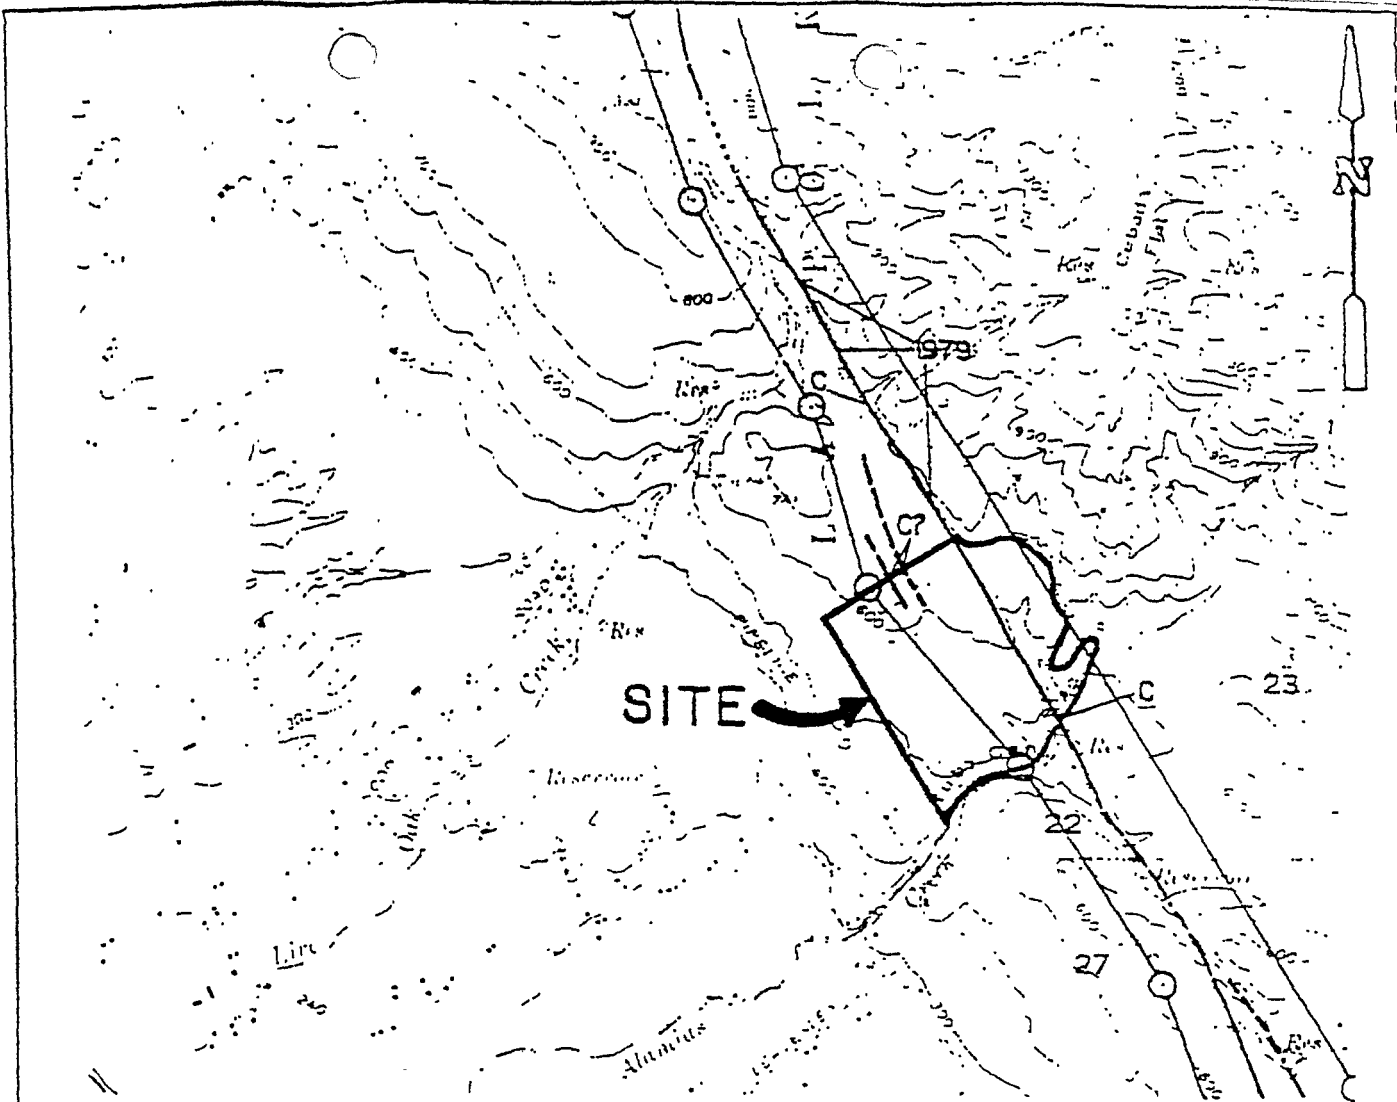
<p>Kaldveer Associates Geoscience Consultants A California Corporation</p>	SPECIAL STUDIES ZONE MAP		
	JAPANESE CULTURAL CENTER Gilroy, California		
	PROJECT NO.	DATE	Figure 2
	K771-4	July 1988

The majority of the site lies within the State of California Special Studies Zone for the Calaveras fault (State of California, 1982), and the trace of the Calaveras fault has been mapped within the property boundaries (Figure 2). The northwest trending Calaveras fault extends from Hollister (San Benito County) northward to at least Danville (Contra Costa County), a distance of over 80 miles (Page, 1982). The Calaveras Fault is a branch of the San Andreas fault system, a major active rift in the earth's crust that extends for at least 450 miles along the California Coast. This fault system also includes the San Andreas and Hayward fault zones, among others. The site is located approximately four miles and eight miles northeast of the Sargent and San Andreas fault zones, respectively, and 20 miles southwest of the southern terminus of the Hayward fault zone. The locations of known faults around the site are shown on Figure 4.
